RAILWAY INVESTIGATION REPORT
R00C0159

CROSSING ACCIDENTS

ATHABASCA NORTHERN RAILWAY LTD.
FREIGHT TRAIN NO. 590-19
MILE 138.07, WATERWAYS SUBDIVISION
IMPERIAL MILLS, ALBERTA
19 DECEMBER 2000

Report Number R00C0159

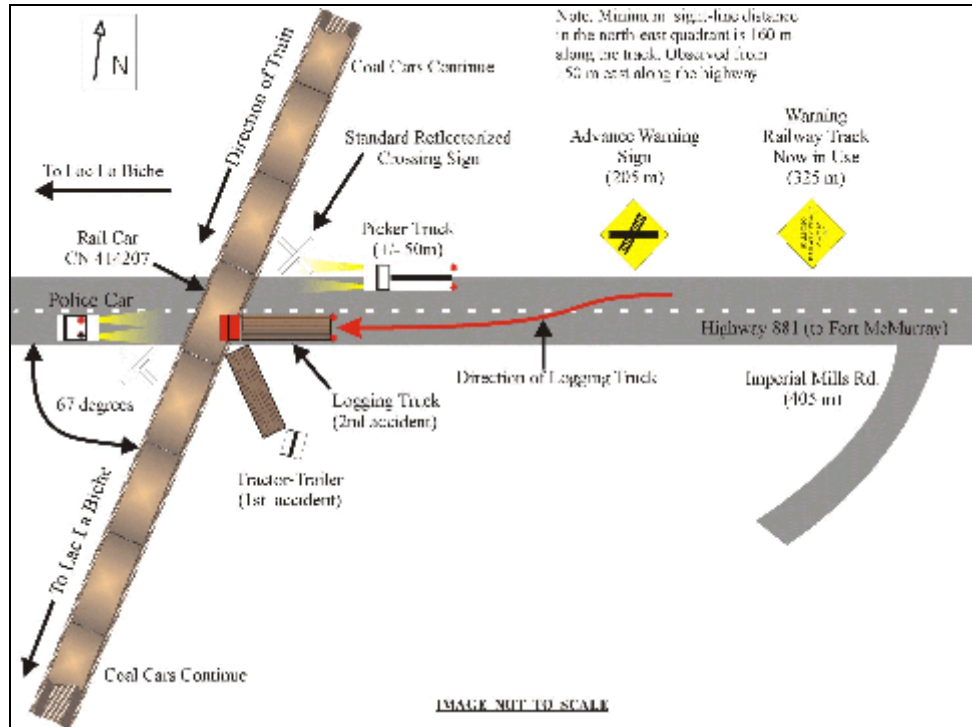
Figure 1 - Sketch showing crossing layout at Mile 138.07

Sight-line distances for westward vehicles located 150 m from the crossing provided a view of approaching southward trains 160 m from the crossing. The view of the standard reflectorized crossing signs (crossbucks) was partially blocked by the position of the picker truck. The angle at which the crossing intersected the roadway was 67 degrees, and the track and highway are both tangent. The roadway approach grades to the crossing were level (see Figure 1).

The sight-line in the north-east quadrant of the crossing at Mile 138.07 would not meet the standards for trucks set out in Transport Canada's draft *Road/Railway Grade Crossings—Technical Standard and Inspection, Testing, and Maintenance Requirements*. The actual SSD was 149 m, compared to the recommended 210 m for trucks travelling up to 80 km/h. Further, the speed limit has now been increased on Highway 881 to 100 km/h, which corresponds to a recommended 330 m SSD for trucks in Transport Canada's draft *Road/Railway Grade Crossings—Technical Standard and Inspection, Testing, and Maintenance Requirements* and 200 m in Alberta Infrastructure's *Highway Geometric Design Guide*. The SSD standards contained in the *Highway Geometric Design Guide* adopted by Alberta in 1999 still do not differentiate between the varying stopping abilities of passenger vehicles and trucks and may lead to a lower level of safety at highway/railway interface points with passive warnings in that province.
